Site Summary Group A  
AREA IV  
Santa Susana Field Laboratory, CA

## Site Summary – Building 4114

## Site Summary – Parking Lot 4511

## Site Summary – Old Conservation Yard

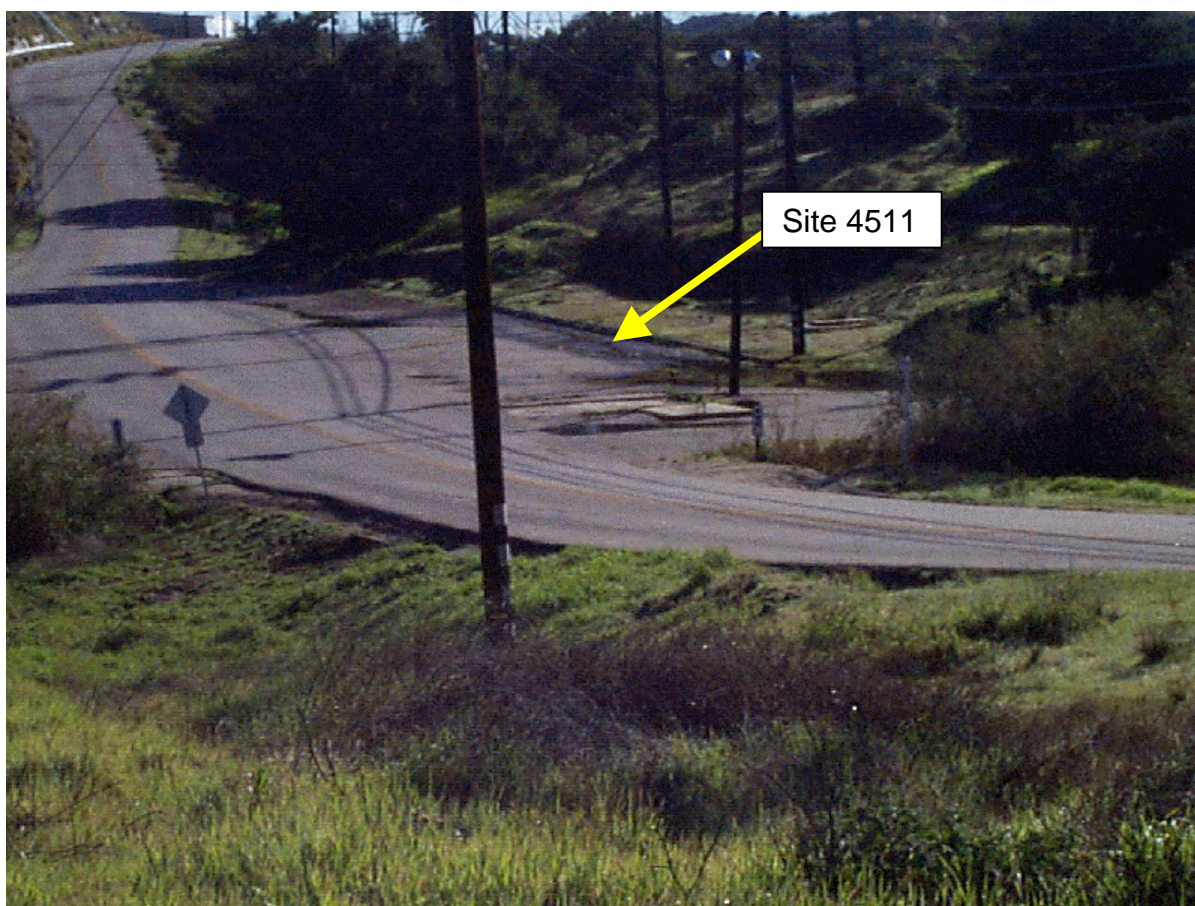
Photograph – Site 4511

- Parking Lot 4511 was an asphalt pad that was located between the OCY and Site 4583.
- Serviced by Guard Shack 4113.
- Serviced by Guard Shack 4623.

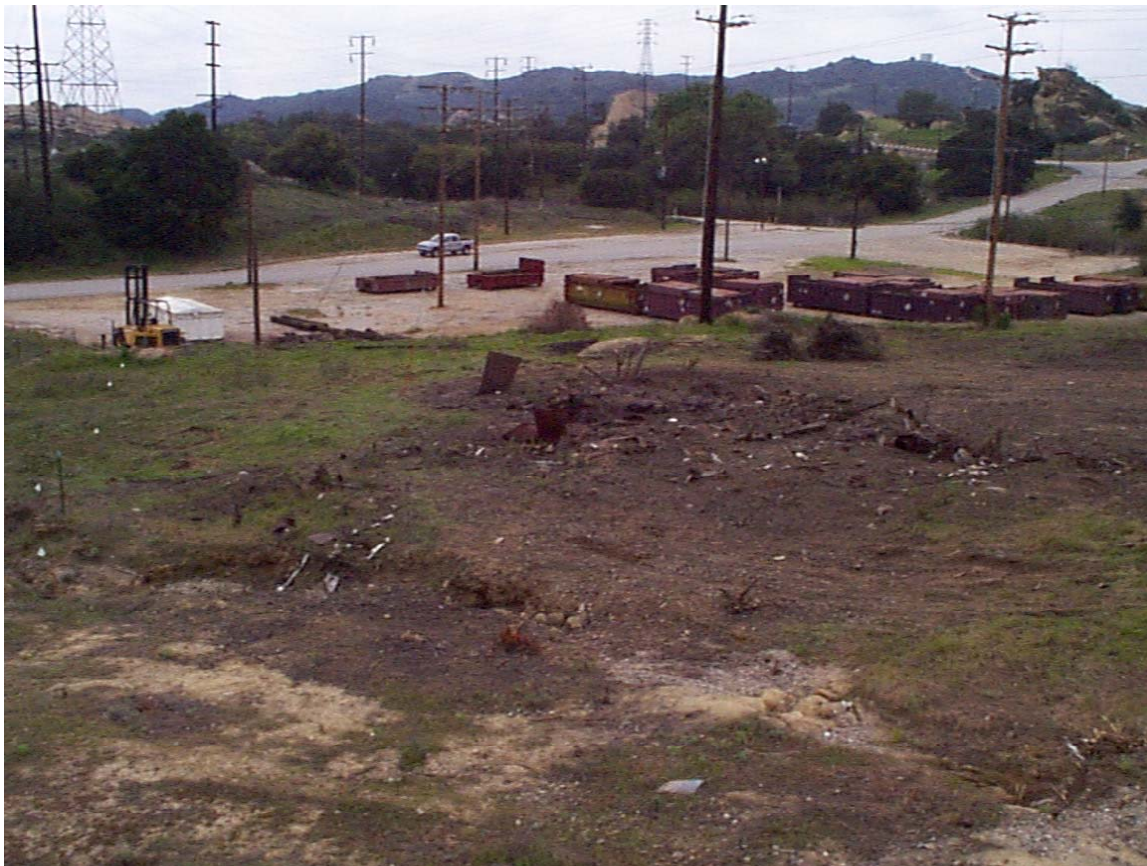
Photograph – Old Conservation Yard (OCY)

- The OCY is a natural terrain yard, and did not have a fenced boundary. It is located on an irregular plateau in a mountainous area and is approximately three acres.<sup>2</sup>
- The Barrel Storage Yard was partially paved, gravel and dirt and is approximately one acre.<sup>1</sup>
- Serviced by Conservation Shack 4313.

- During this survey, ambient gamma exposure measurements within the fenced storage yard indicated a contaminated mud puddle in the southwest corner of the Barrel Storage/Conservation Yard. The value was approximately three times ambient background, above the acceptable limits (5 µR/hr above ambient background). Additional soil samples were collected in this area.

- All other areas of the site were below Derived Concentration Guideline Levels for ambient gamma exposure rates.
  - Soil sampling in the area found the average Cs-137 concentration at 81 pCi/g, which was above the DCGL of 60.4 pCi/g.

- The site was remediated in 1989 to remove contamination found during the 1988 radiological survey. The top four inches of soil were removed from a 20-foot by 20-foot area in the Barrel Storage/Conservation Yard. Confirmation samples were collected.<sup>2</sup>

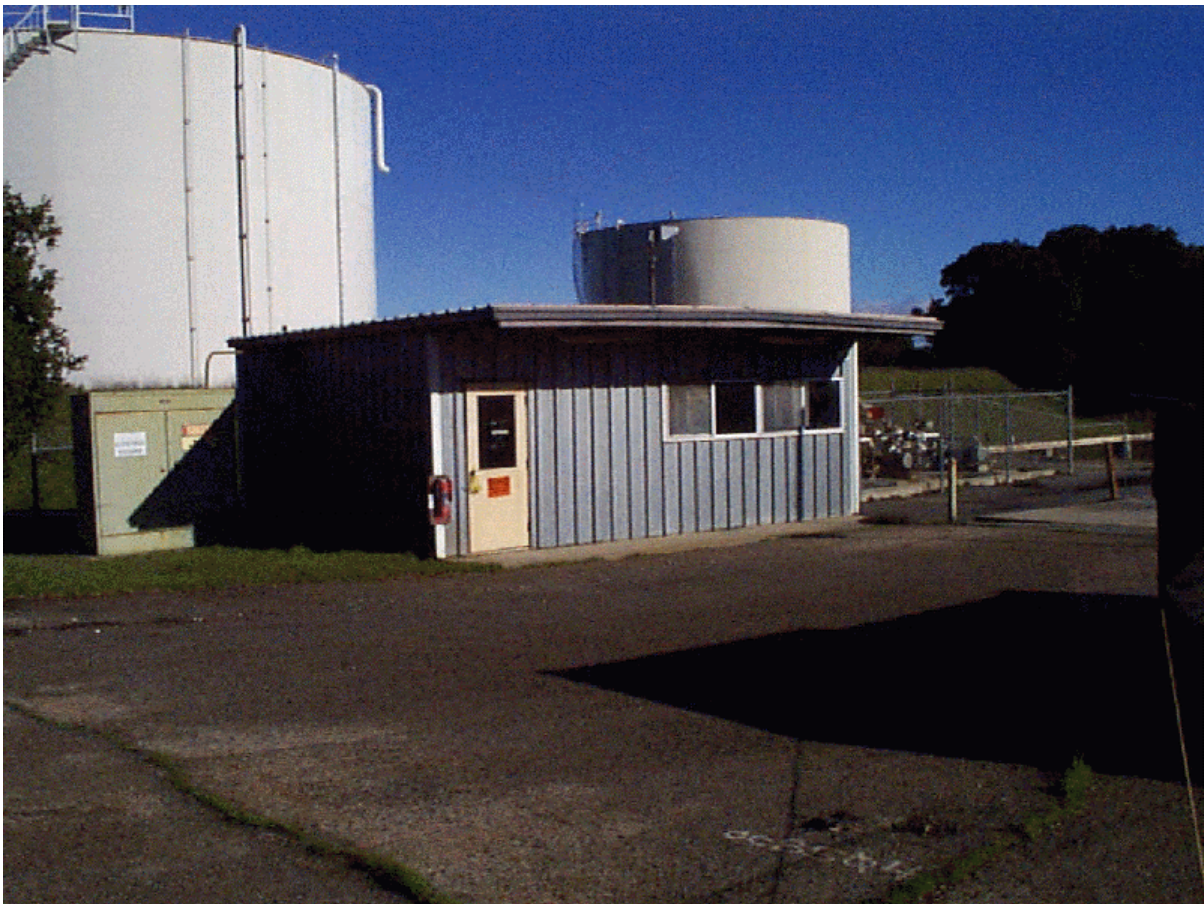
Photograph – Building 4320

- Building 4320 was a 500-square-foot structure constructed of prefabricated steel. It sat on a concrete pad and was connected to the tanks by carbon steel pipes ranging from three to six inches in diameter. The entire area was fenced and paved.

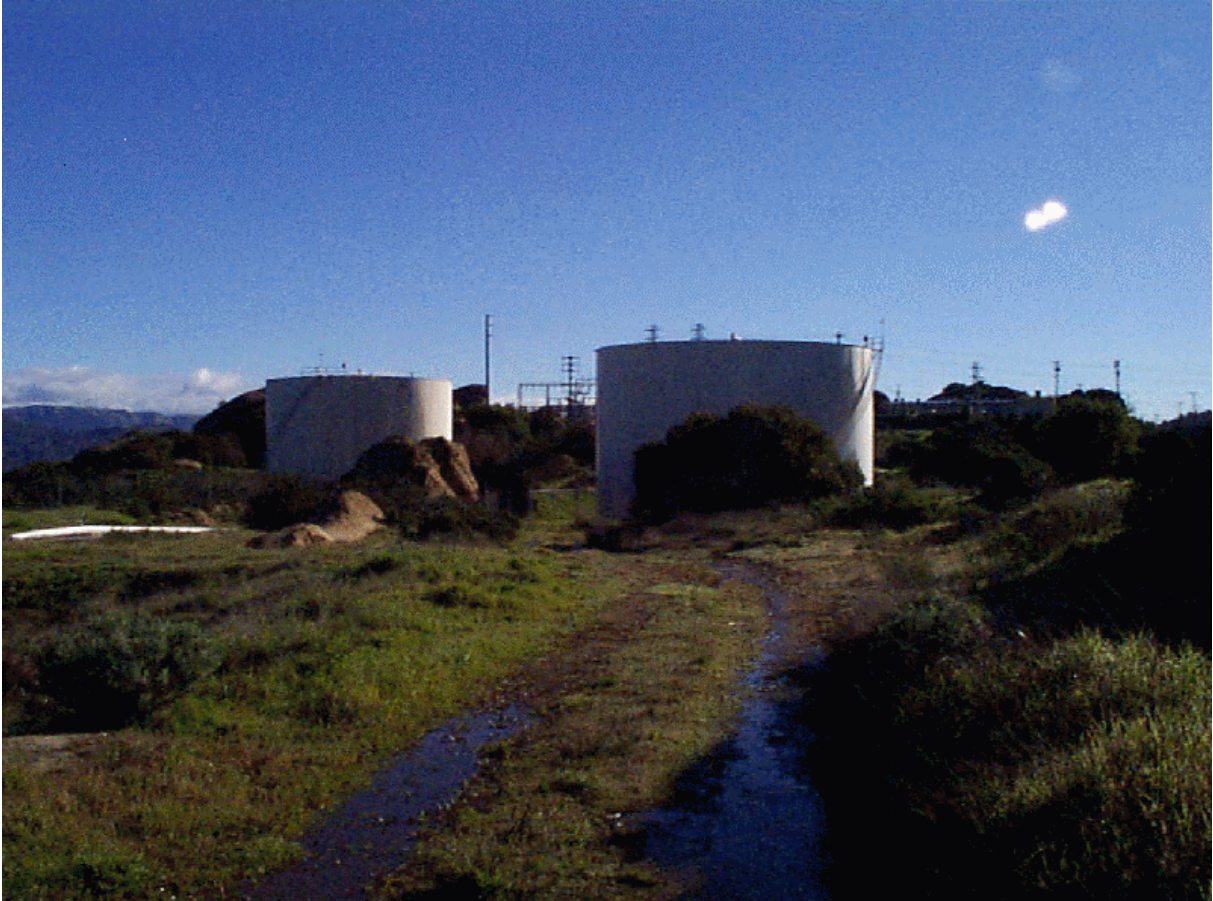
Photograph – Building 4731

- Building 4731 had a capacity of 1.5 million gallons, and measured 74 feet in diameter and 48 feet high. It was above ground, vented and constructed of carbon steel. The Fuel Tank Farm also contained a pump station and interconnecting piping systems, a control building, concrete supports and foundations, asphalt paving and chain link fencing.<sup>2</sup>

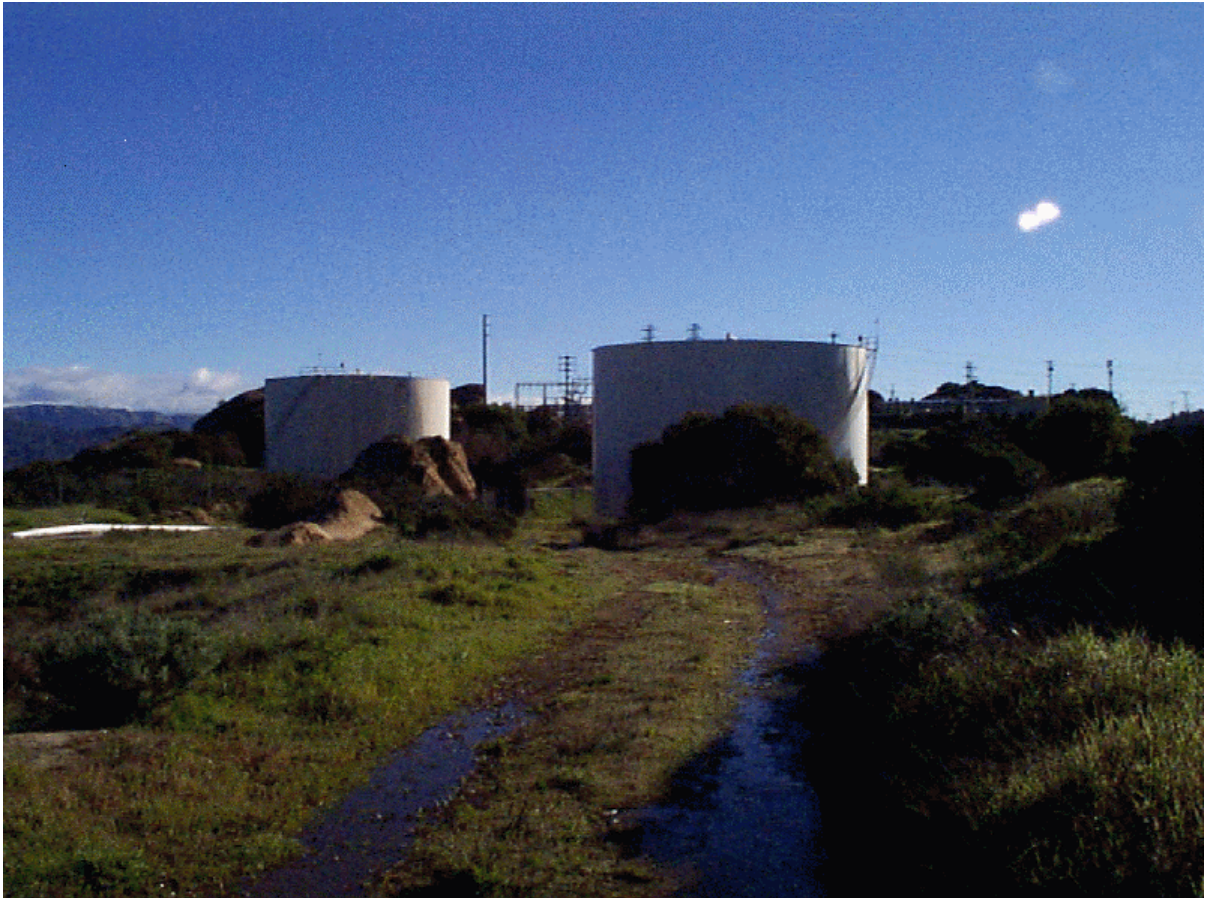
Photograph – Building 4732

- Building 4732 had a capacity of 1.5 million gallons, and measured 74 feet in diameter and 48 feet high. It was above ground, vented and constructed of carbon steel. The Fuel Tank Farm also contained a pump station and interconnecting piping systems, a control building, concrete supports and foundations, asphalt paving and chain link fencing.<sup>2</sup>

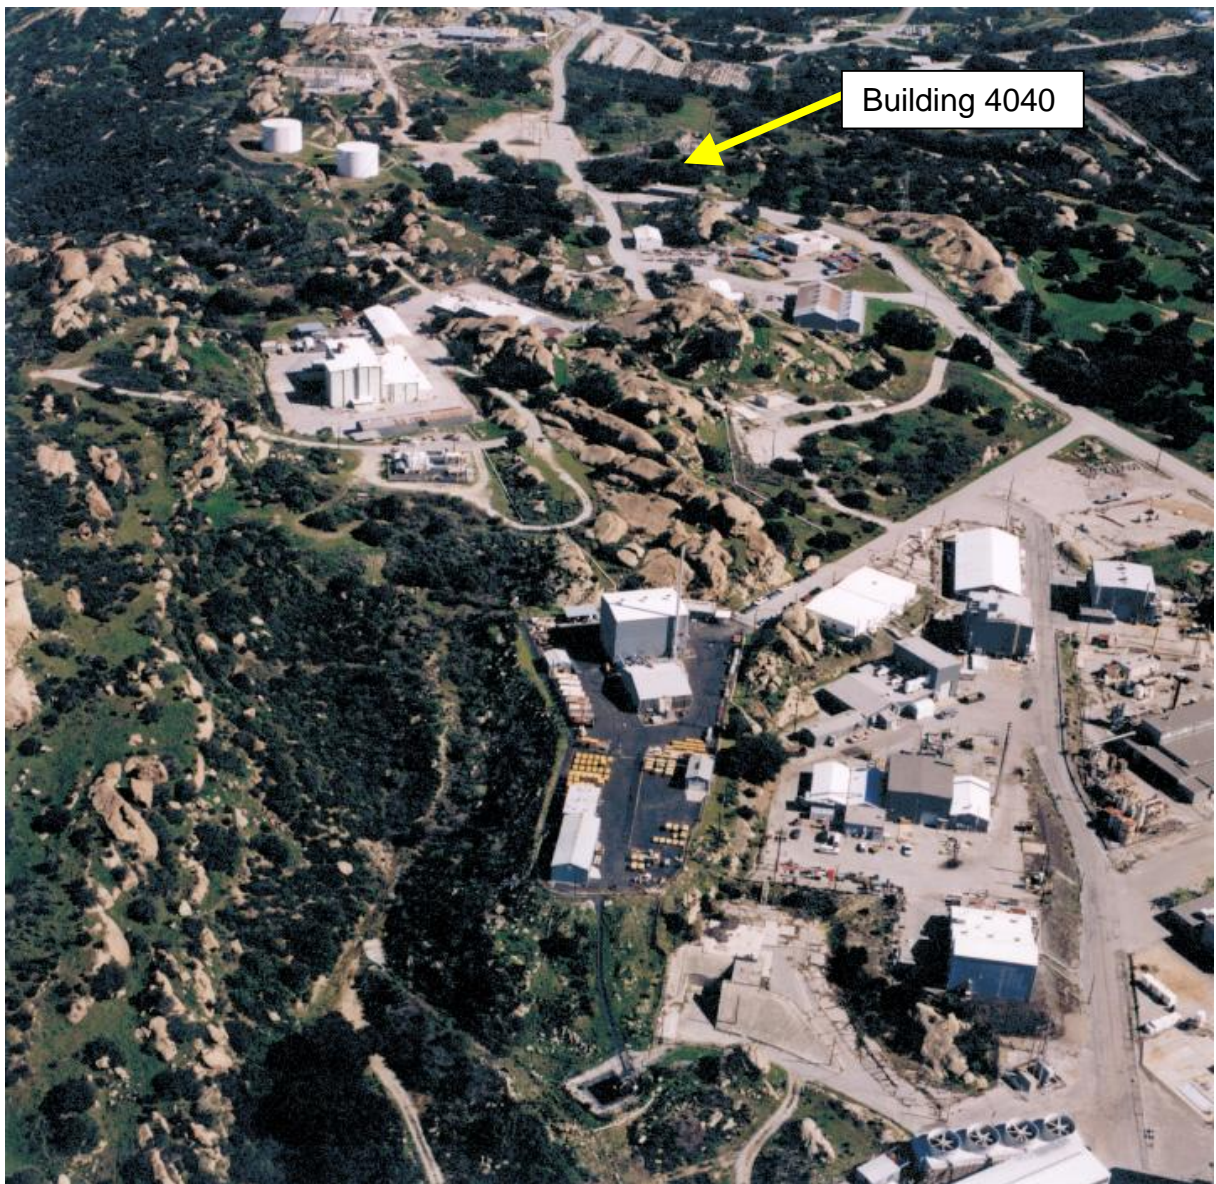
Photograph – Building 4040

- Building 4040 was a 2,800-square-foot structure with steel walls, a steel roof and a concrete slab floor.<sup>1</sup>
- Building 4624, a fire truck canopy, was adjacent to Building 4040 and appears only on the 1962 Industrial Planning Map.<sup>3</sup>
